INSPECTION REPORT

For the Property at:
1234 NICE STREET
YOUR TOWN, IL

Prepared for: JON DOE
Inspection Date: Friday, December 8, 2006
Prepared by: Thomas Jansson 450.0003340

Acuity Home Inspection Service
1340 W Farwell Ave
Chicago, IL 60626
312-217-5249
www.insightinspec.com
tj@insightinspec.com

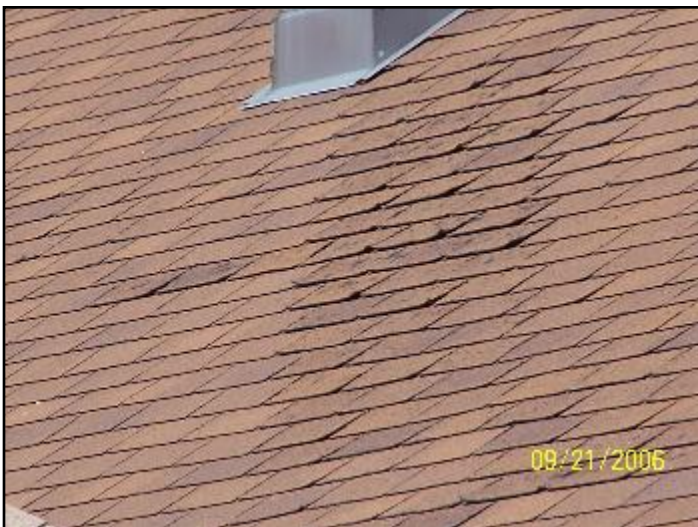
Condition: • [Old, worn out](#)

Note: Asphalt roof is showing signs of extensive wear. Roof replacement required. Recommend inspection/estimate by a licensed roofing contractor prior to close of escrow.

Curling shingles

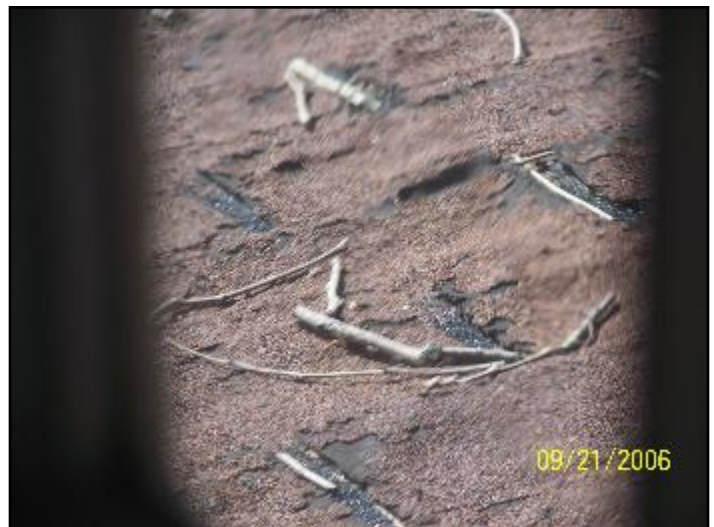
granule loss, surface deterioration

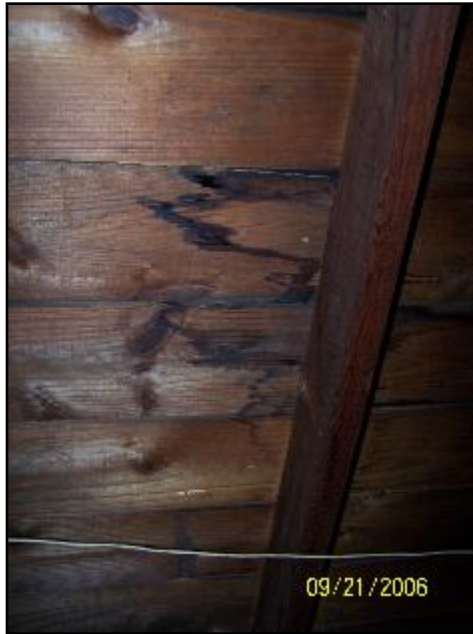
water stains on duckboards

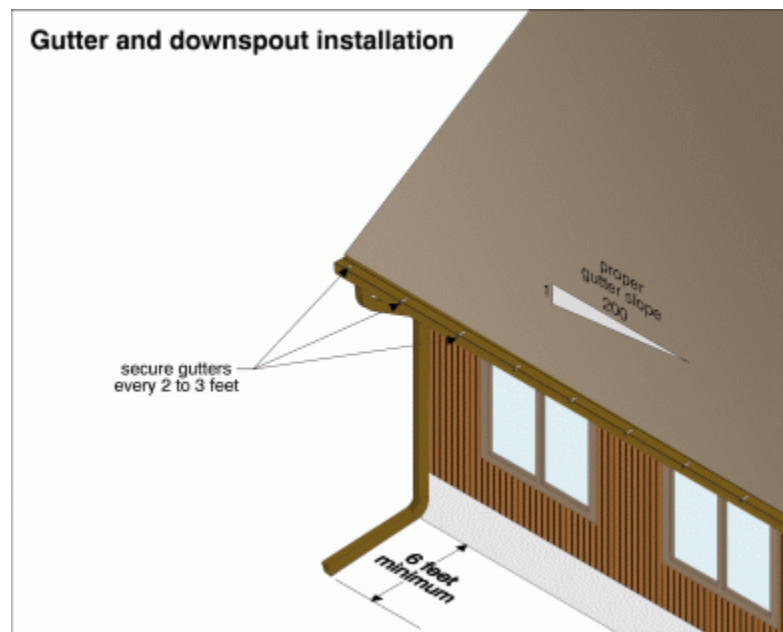
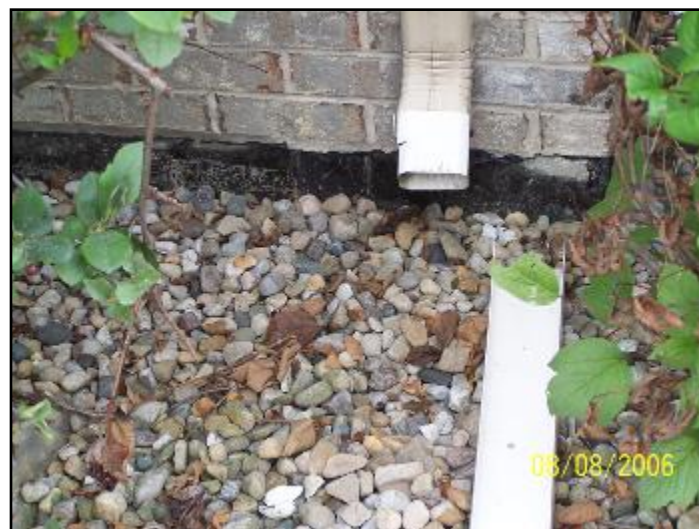
Note: Downspouts discharge too close to building. May lead to problems with water in the basement. Open extensions (pictured) can overflow and are not an optimal solution. Recommend extending the downspouts to discharge six feet away from the foundation wall. Contact a licensed gutter or drainage contractor.

Downspout too close to house

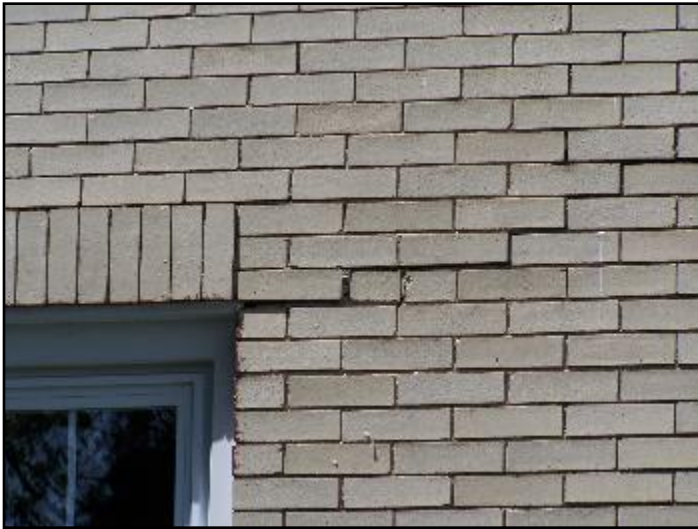
Note: Tuckpointing needed throughout. Also noted masonry cracks at upper window edges. This is a sign that the lintels are rusting. Lintel pockets should be repaired by qualified masonry contractors. All lintels should be scraped and rustproofed by qualified contractors as a matter of routine maintenance.

Masonry crack at window edge

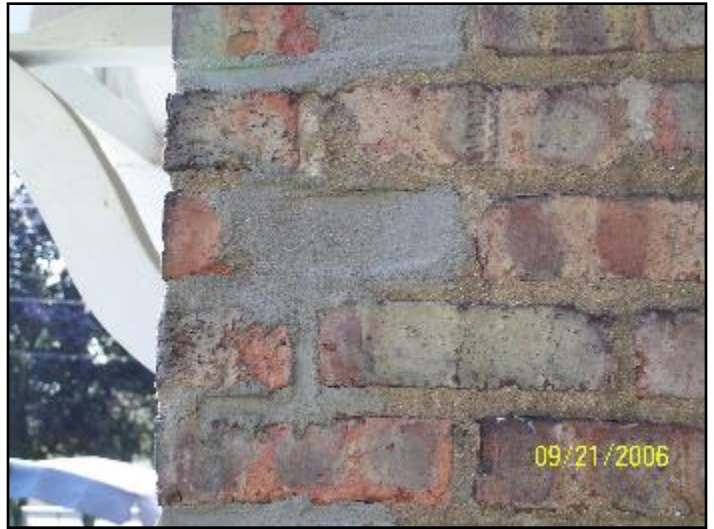
Previously repaired areas

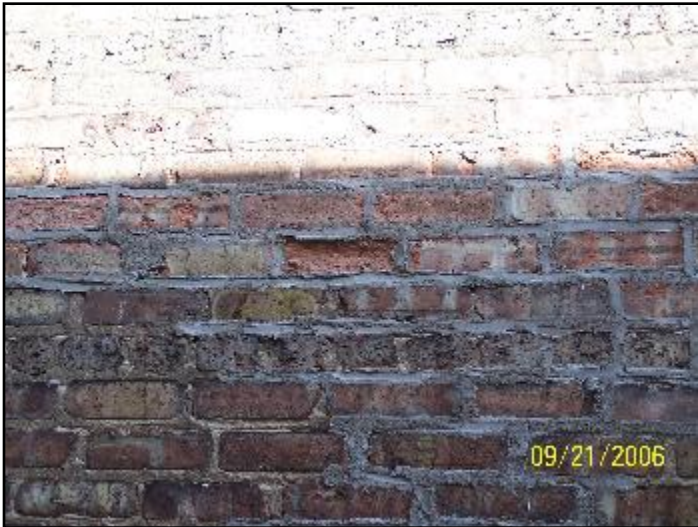
Spalling, masonry deterioration

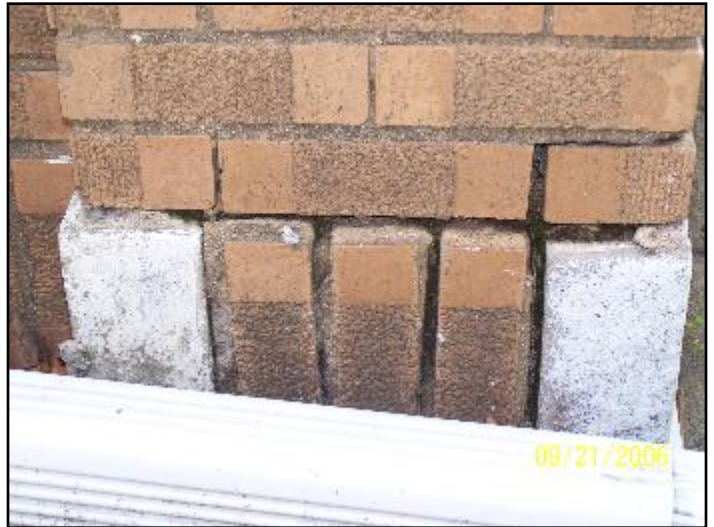
Tuckpointing urgently needed

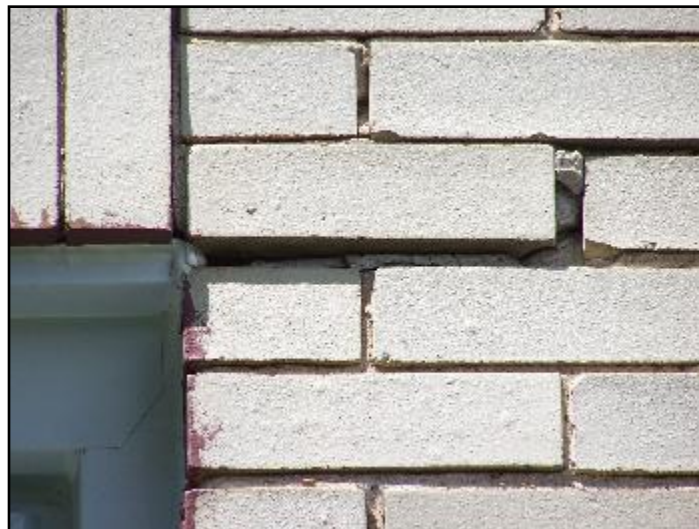
mortar damage from rusting lintel

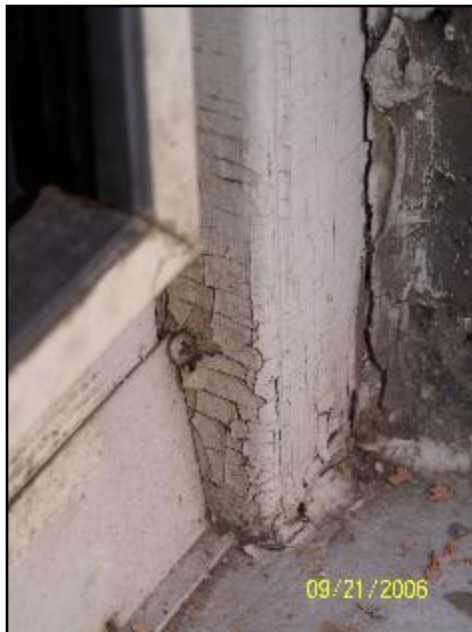
Note: Rot beginning to develop at some of the basement windows. Replacement is not necessary at this point, but all windows should be monitored as part of the homeowner's ongoing maintenance program. SCRAPING AND PAINTING is needed immediately to prevent further deterioration of the windows.

Scraping, painting, caulk needed throughout

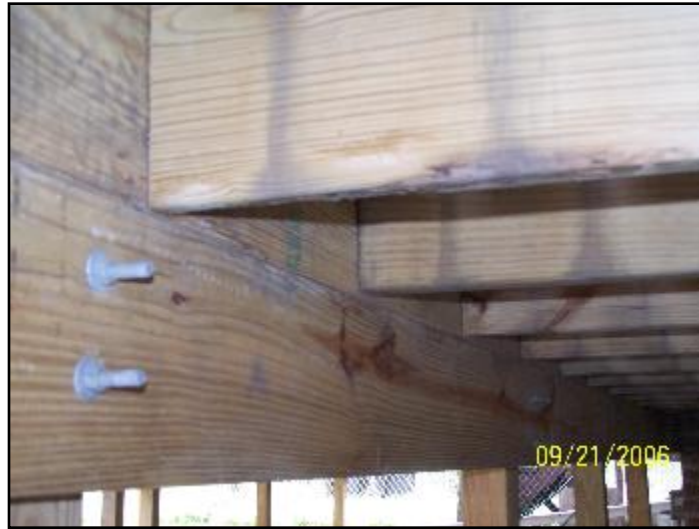
Note: Joist hangers missing on sections of the back porch. HEALTH/SAFETY ISSUE. Have missing fasteners installed by a licensed porch specialist prior to closing.

Joist Hangers Missing. Inadequate support.

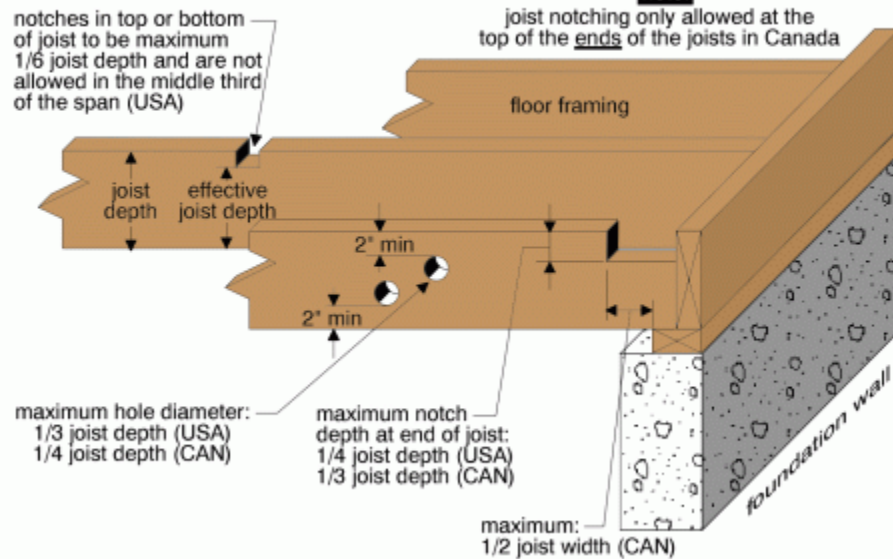
Joist notching and drilling

Note: Cut and notched joists found. Structural repairs are required. Contact a licensed, qualified carpenter for an estimate prior to closing.

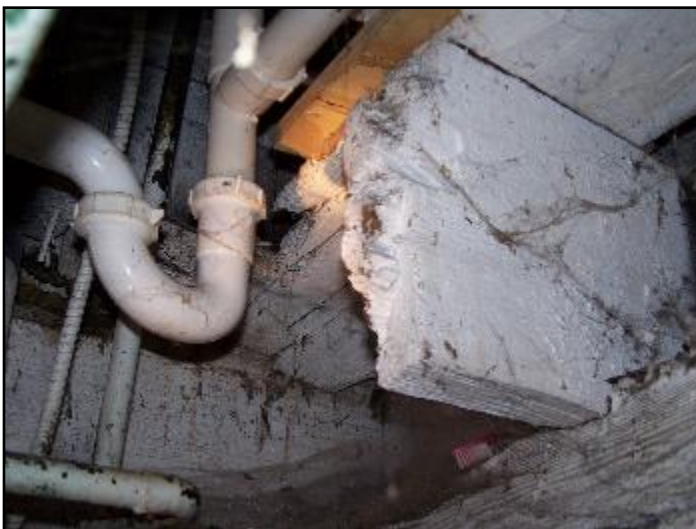
Cut joist

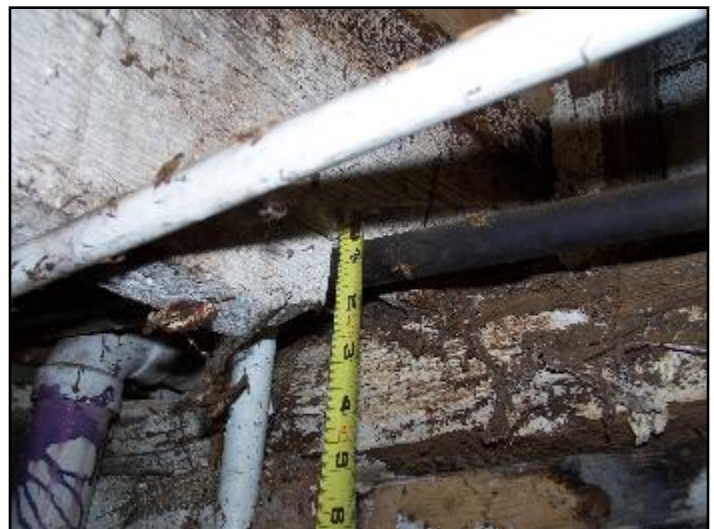
Joist notched too deep

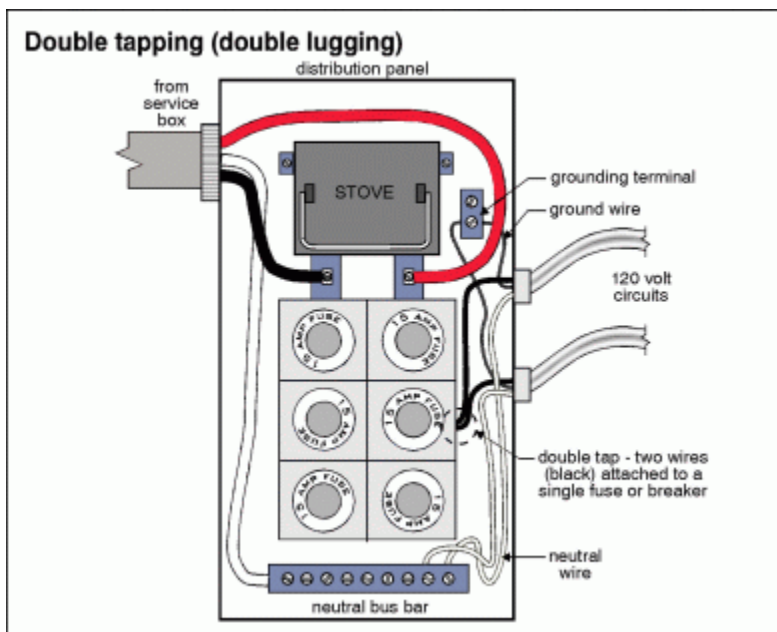
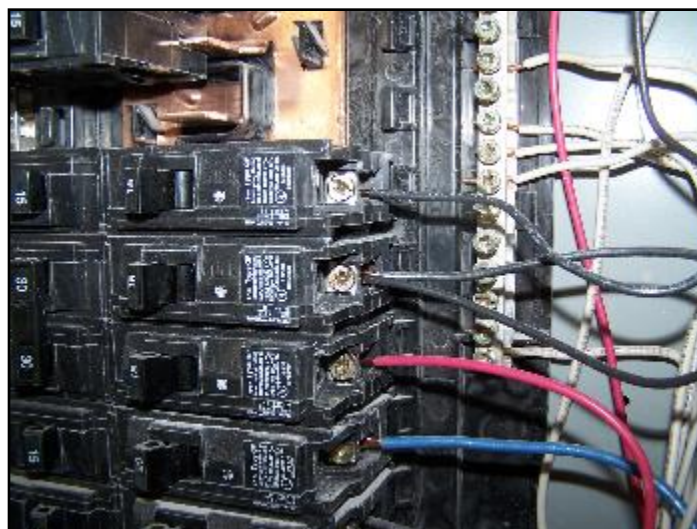
Condition: • [Double taps](#)

Double Taps

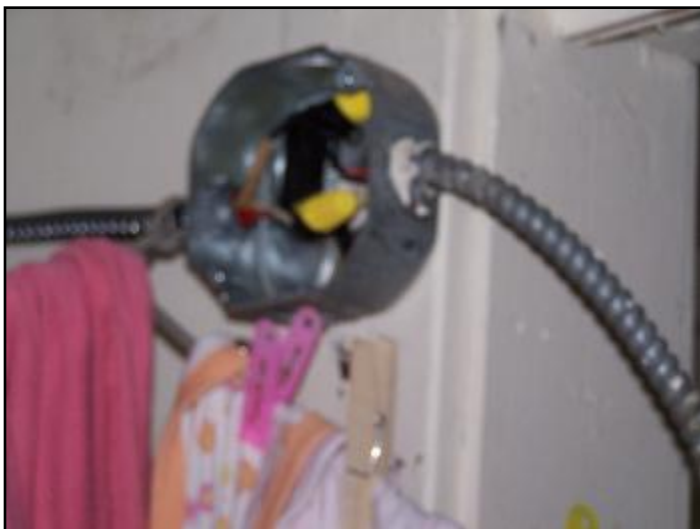
Open junction box

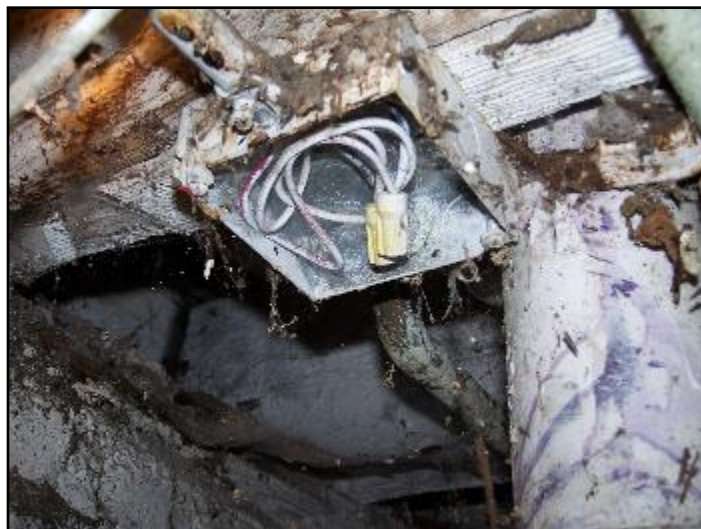
Open junction box

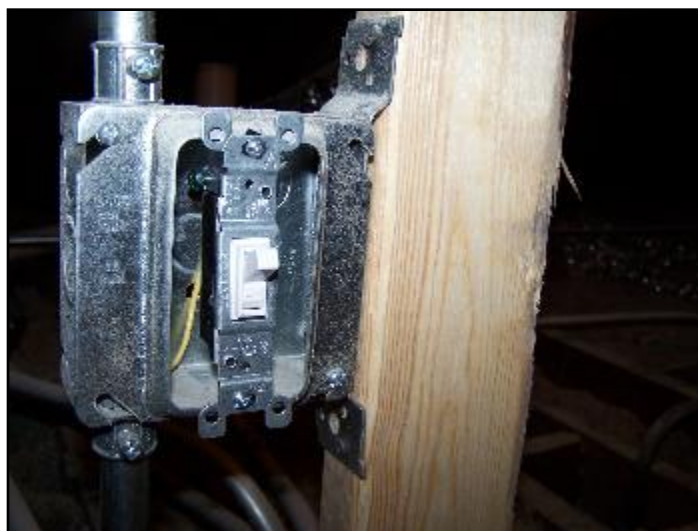
Missing switchplate cover

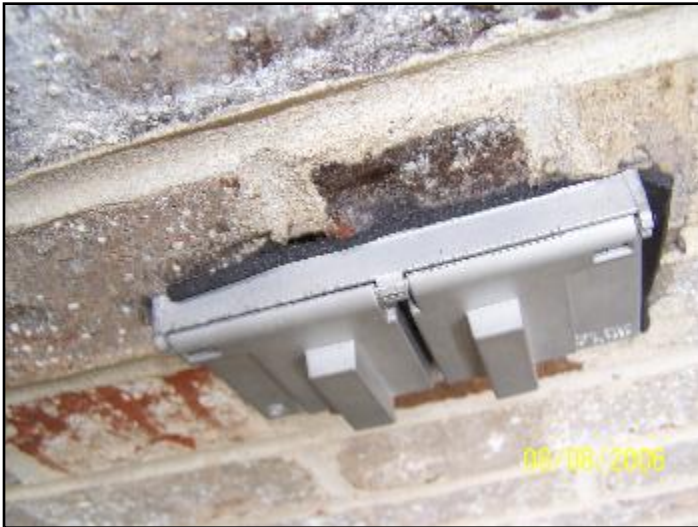
Note: Outlet issues noted throughout. ALL outlets should be examined and repaired or replaced by a licensed electrician prior to closing.

Exterior outlet not watertight, needs GFI

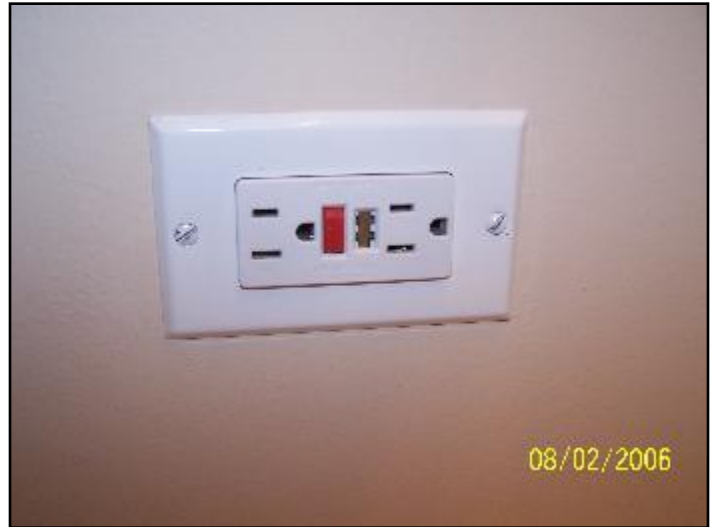
Damaged GFI

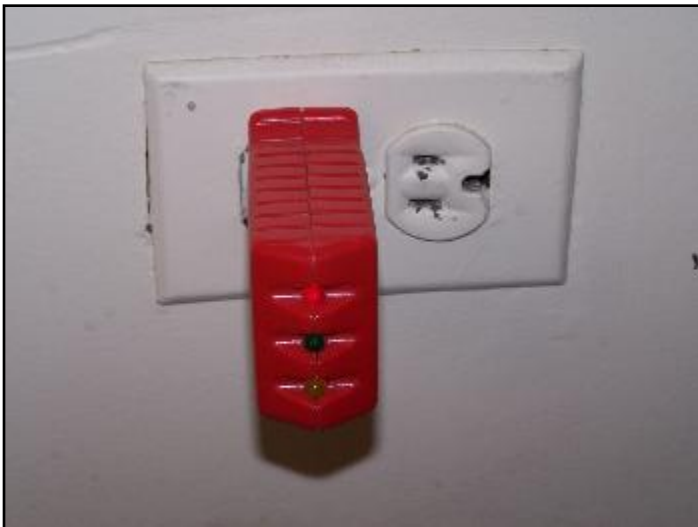
Bad ground

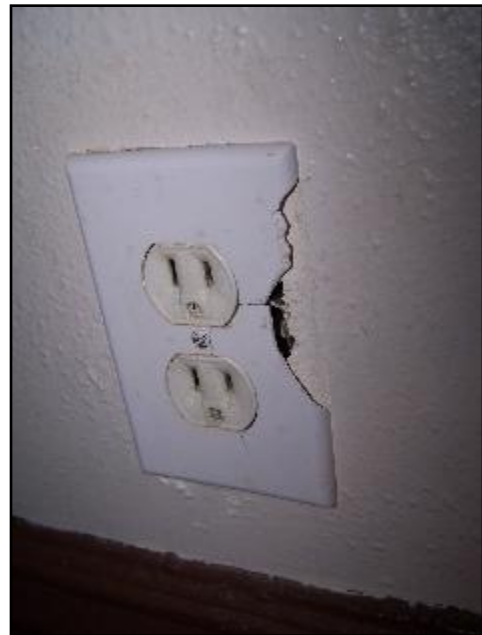
Cracked cover, paint clogged - replace

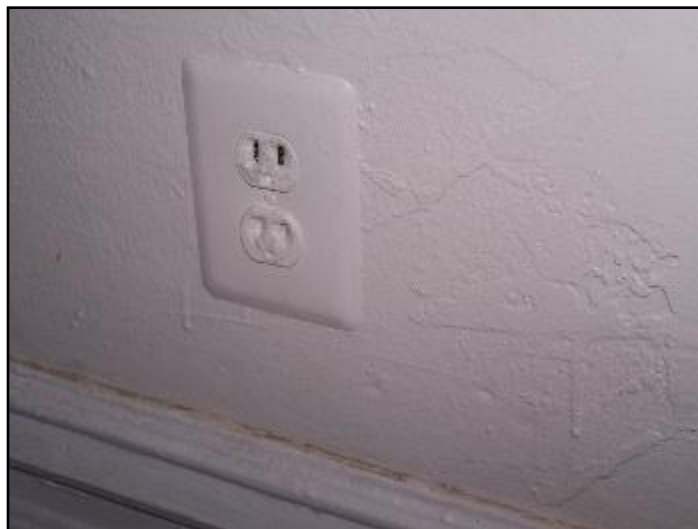
Paint damaged - replace

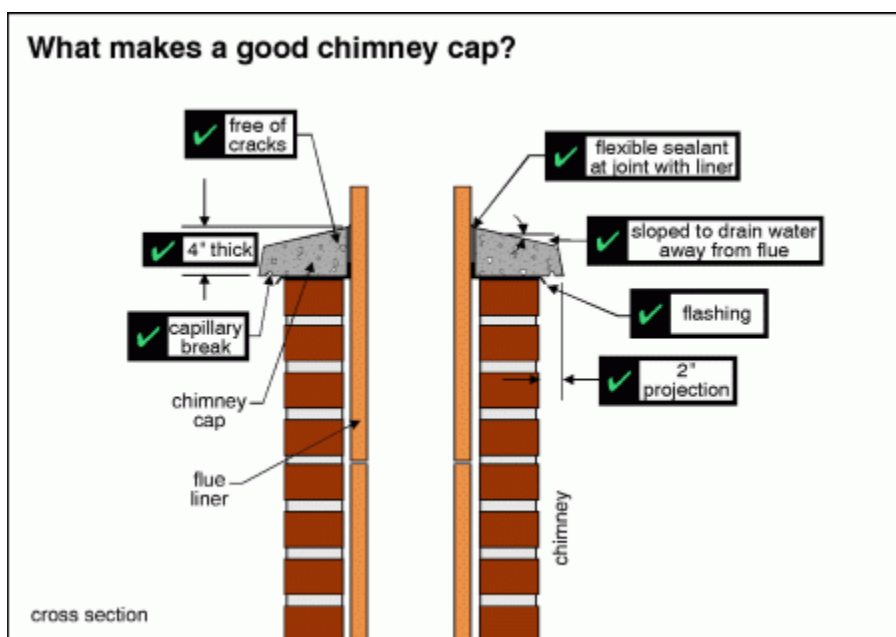
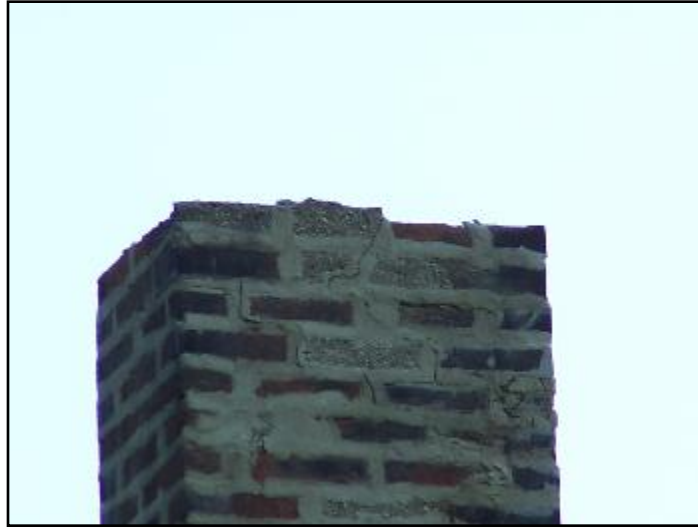
A chimney cap is necessary to prevent damage to the chimney from moisture intrusion and the freeze/thaw cycle.

Missing chimney cap; previous repairs

Note: Contact licensed masonry contractor for chimney cap replacement.

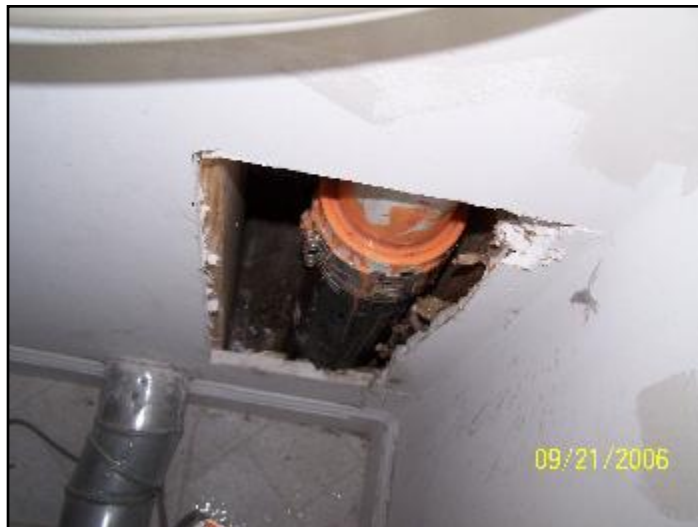
Note: Leaking waste stack found behind washing machine. Cannot determine location of the leak as the stack is enclosed by the walls. It will most likely be necessary to open up the walls in this section of the house in order to identify and repair the leak. This is a problem which requires immediate attention from a licensed plumber.

Leaking waste stack

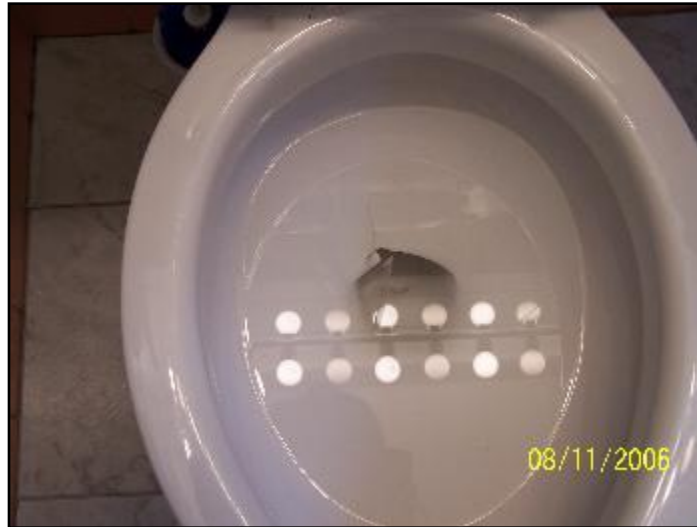
Note: Toilet is cracked and should be replaced by licensed plumber prior to closing.

Cracked toilet bowl

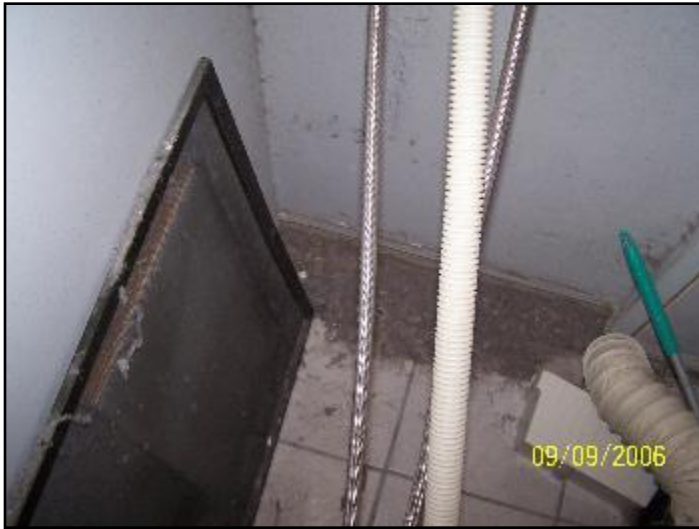
Note: Potential FIRE HAZARD.

Lint pile behind dryer. Fire Hazard.

Dryer should be vented to exterior with metal ducting. Plastic (or vinyl) ducting is flammable and should be replaced. Lint buildup is a significant FIRE HAZARD. Have Dryer Cleaned and Serviced by licensed appliance specialist prior to occupancy. Have Dryer vented to the outside using metal ductwork.

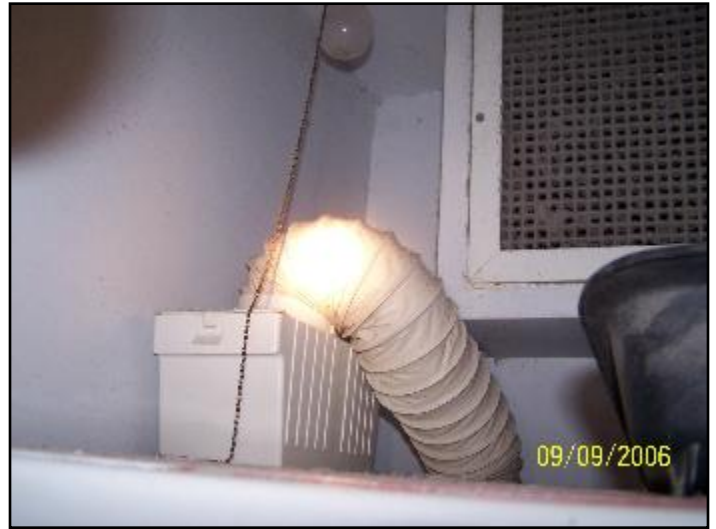
Lint trap, vinyl hose are fire hazards.

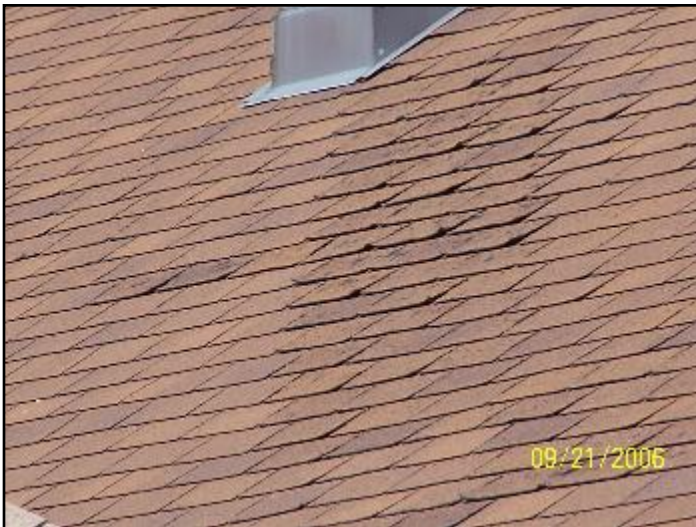
Note: Asphalt roof is showing signs of extensive wear. Roof replacement required. Recommend inspection/estimate by a licensed roofing contractor prior to close of escrow.

Curling shingles

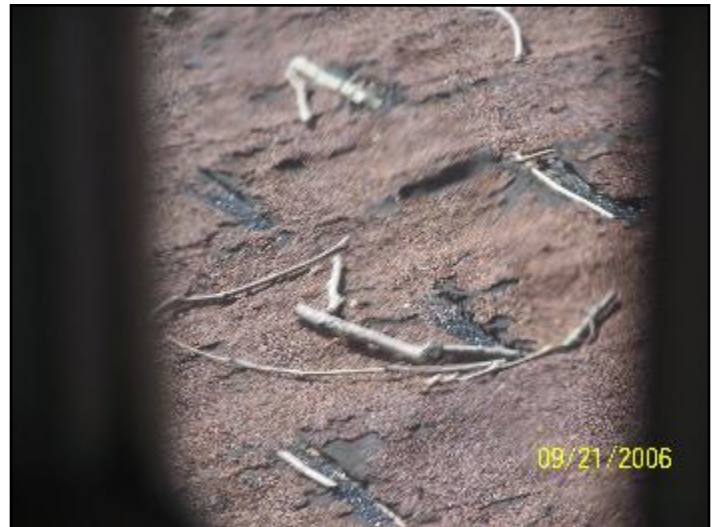
Note: Noted worn areas, granule loss, evidence of previous moisture intrusion.

granule loss, surface deterioration

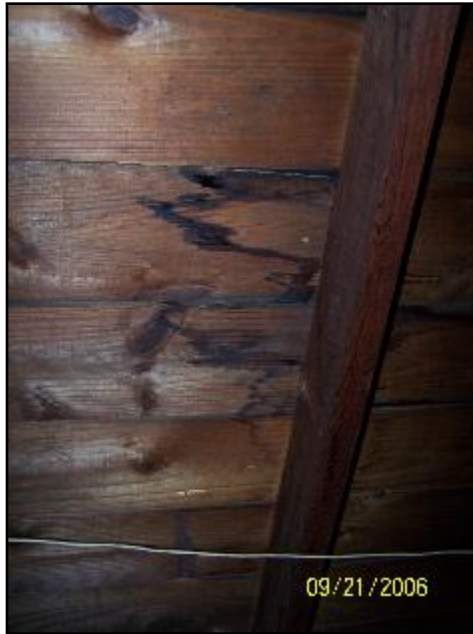
water stains on duckboards

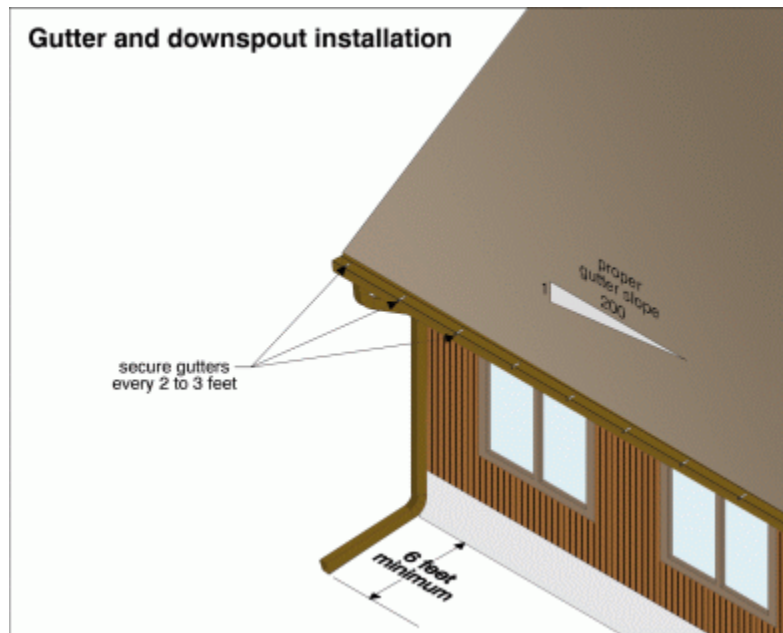
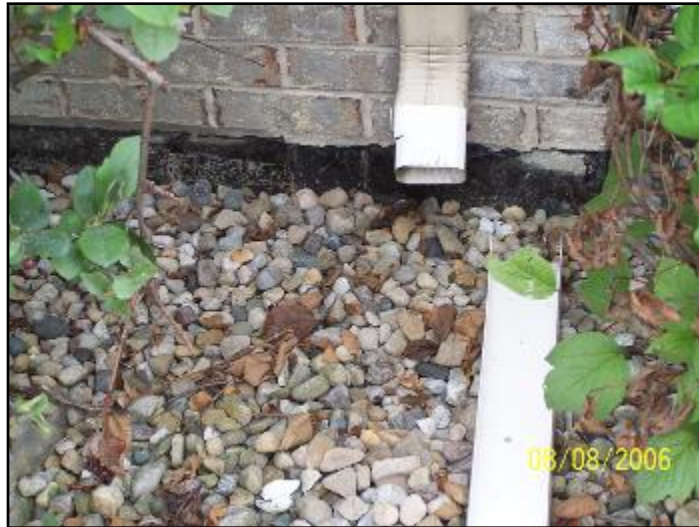
Note: Downspouts discharge too close to building. May lead to problems with water in the basement. Open extensions (pictured) can overflow and are not an optimal solution. Recommend extending the downspouts to discharge six feet away from the foundation wall. Contact a licensed gutter or drainage contractor.

Downspout too close to house

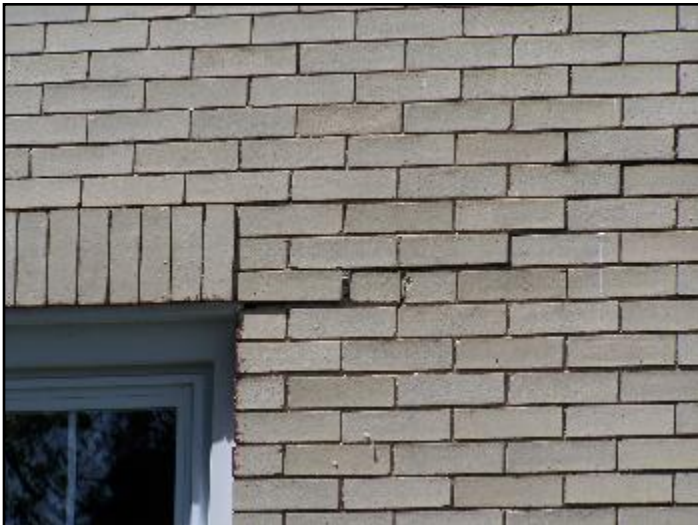
Note: Tuckpointing needed throughout. Also noted masonry cracks at upper window edges. This is a sign that the lintels are rusting. Lintel pockets should be repaired by qualified masonry contractors. All lintels should be scraped and rustproofed by qualified contractors as a matter of routine maintenance.

Masonry crack at window edge

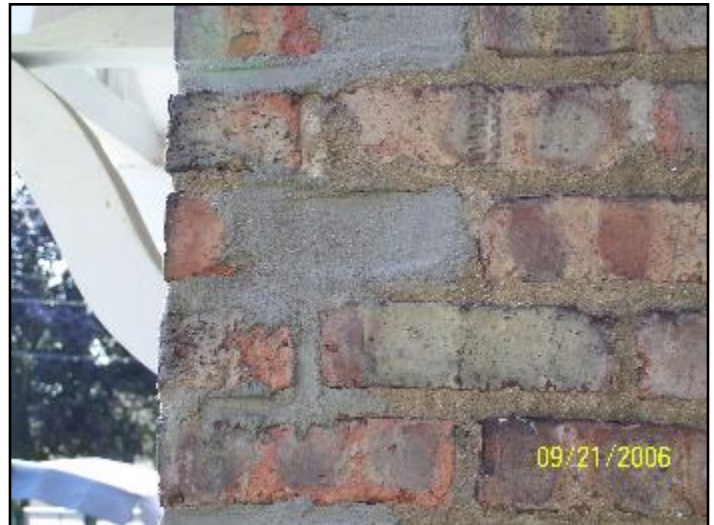
Previously repaired areas

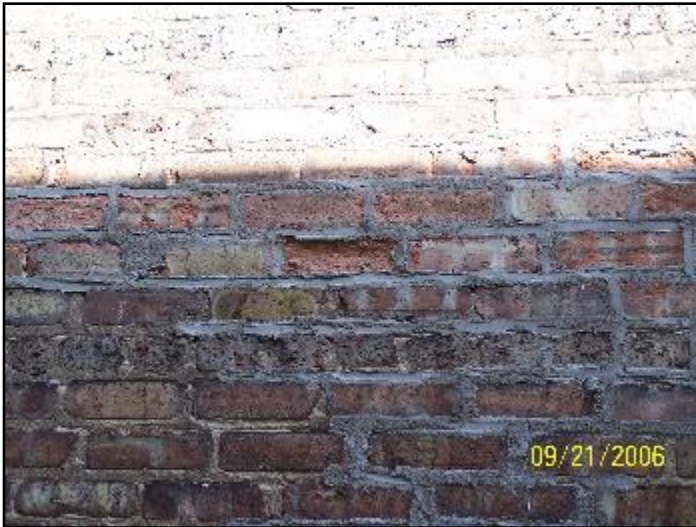
Spalling, masonry deterioration

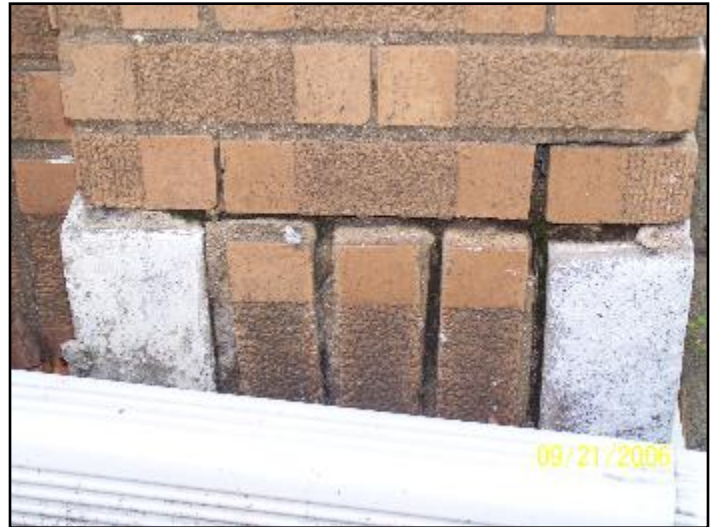
Tuckpointing urgently needed

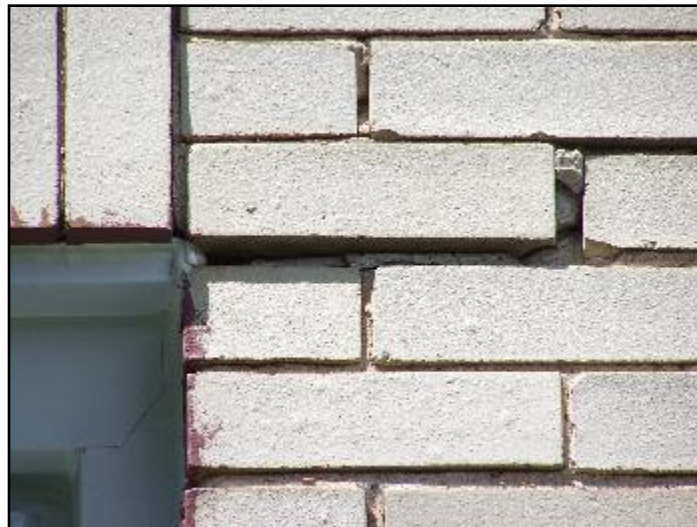
mortar damage from rusting lintel

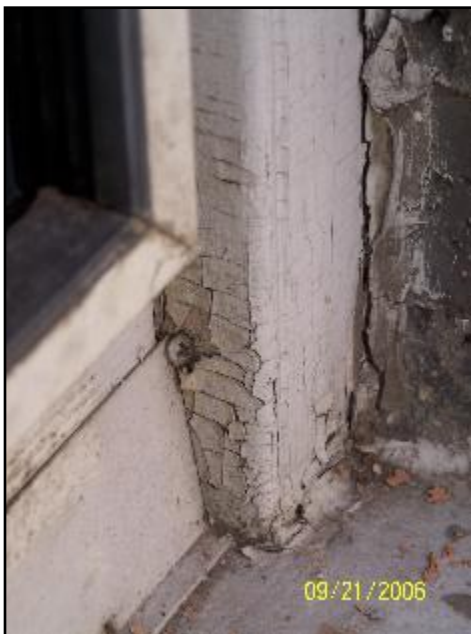
Note: Rot beginning to develop at some of the basement windows. Replacement is not necessary at this point, but all windows should be monitored as part of the homeowner's ongoing maintenance program. SCRAPING AND PAINTING is needed immediately to prevent further deterioration of the windows.

Scraping, painting, caulk needed throughout

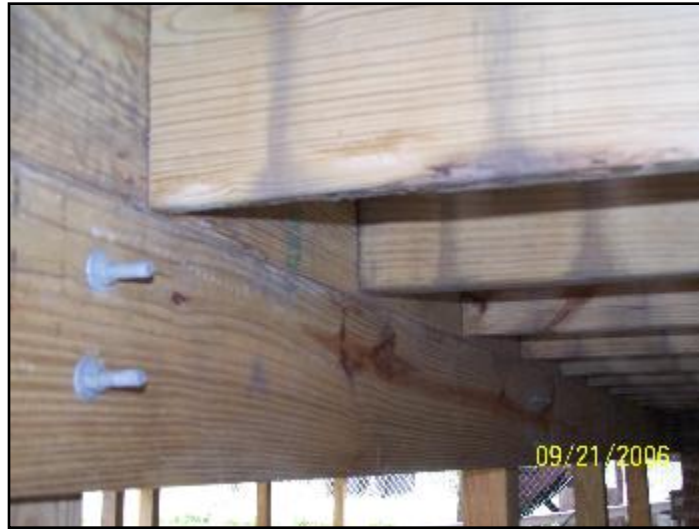
Note: Joist hangers missing on sections of the back porch. HEALTH/SAFETY ISSUE. Have missing fasteners installed by a licensed porch specialist prior to closing.

Joist Hangers Missing. Inadequate support.

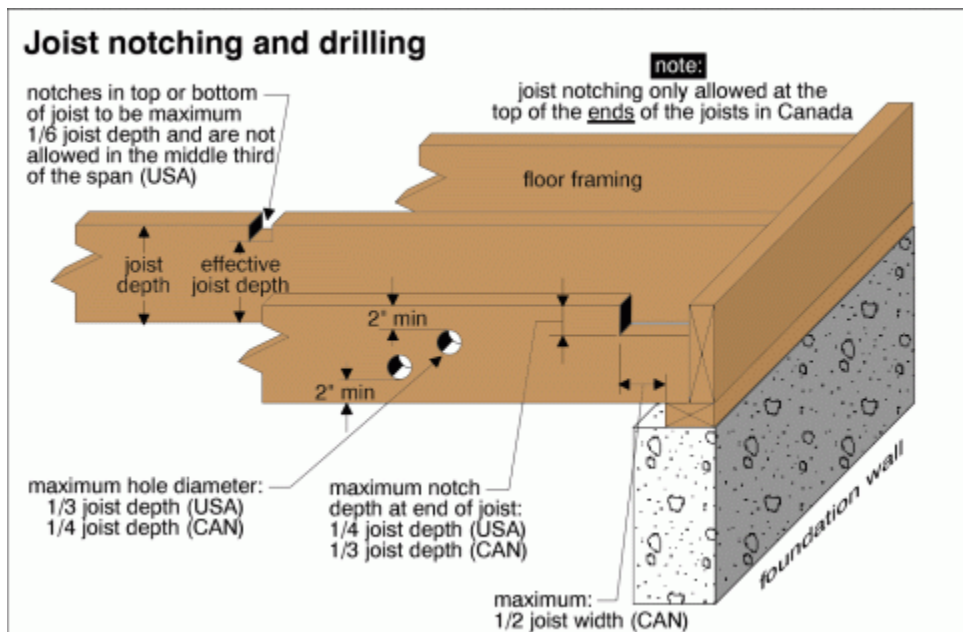
Note: Cut and notched joists found. Structural repairs are required. Contact a licensed, qualified carpenter for an estimate prior to closing.

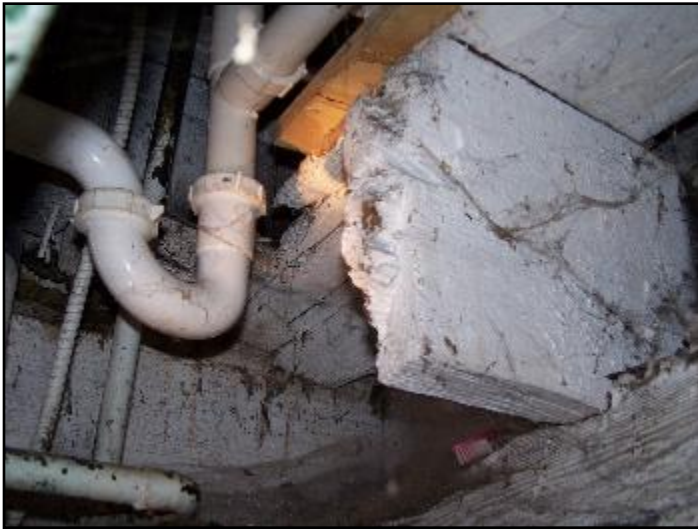
Cut joist

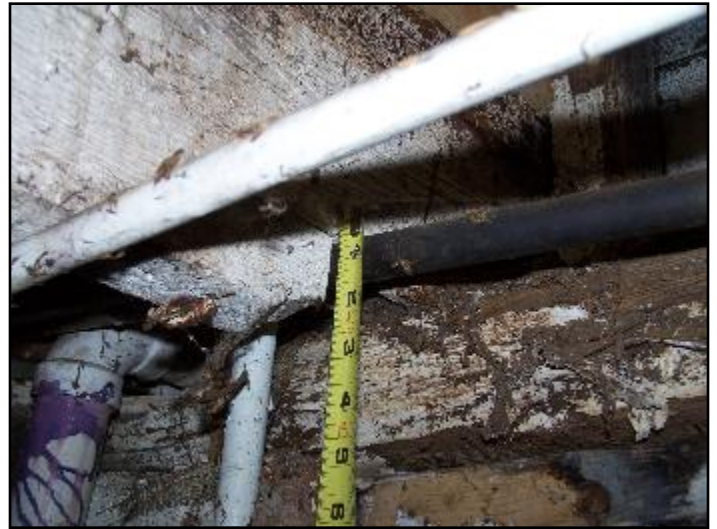
Joist notched too deep

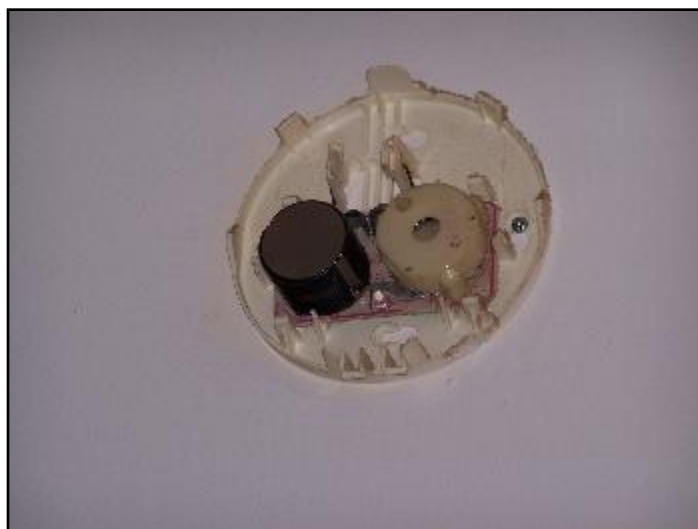
Smoke detectors: • Disabled

Smoke detectors disabled

Note: All smoke detectors must have new batteries installed and must be tested prior to occupancy.

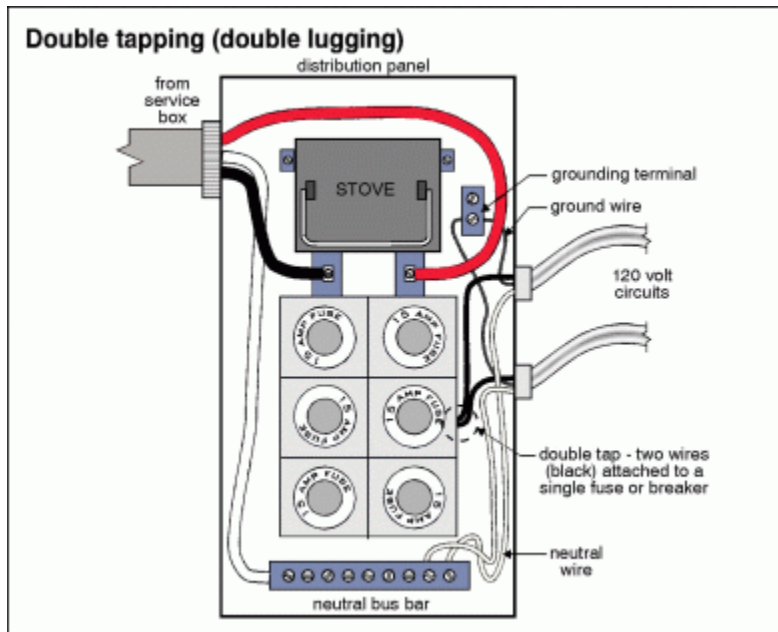
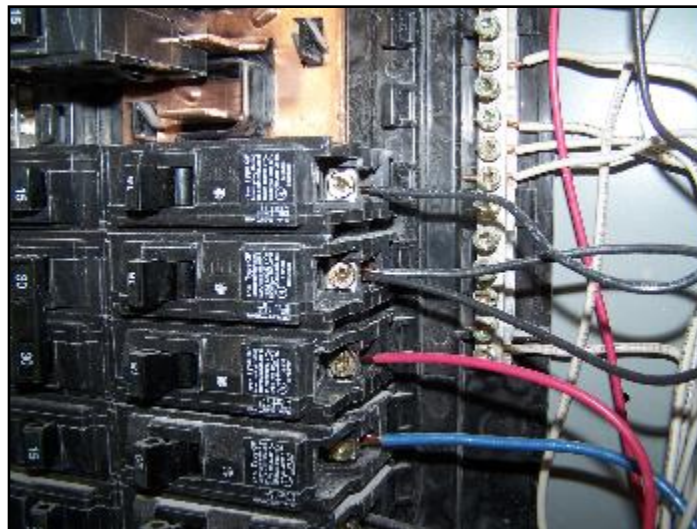
Condition: • [Double taps](#)

Double Taps

Note: Contact electrician to install additional circuit breakers to eliminate double taps. There is plenty of room in this panel to properly accommodate the current wiring requirements of the house.

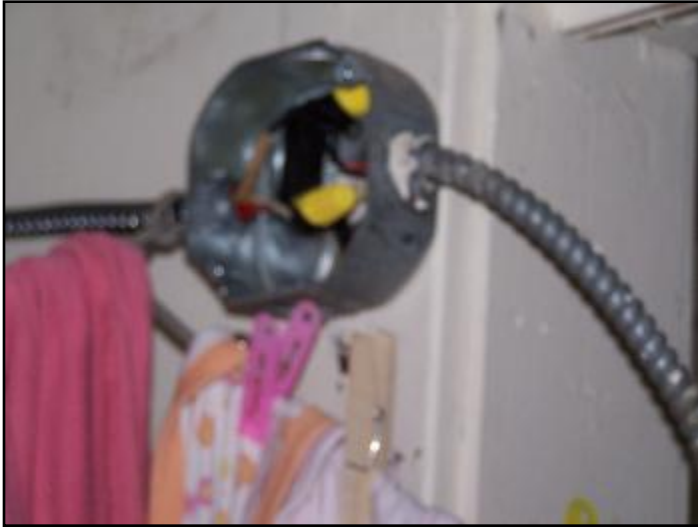
Open junction box

Note: All open junction boxes should be covered by a licensed electrician.

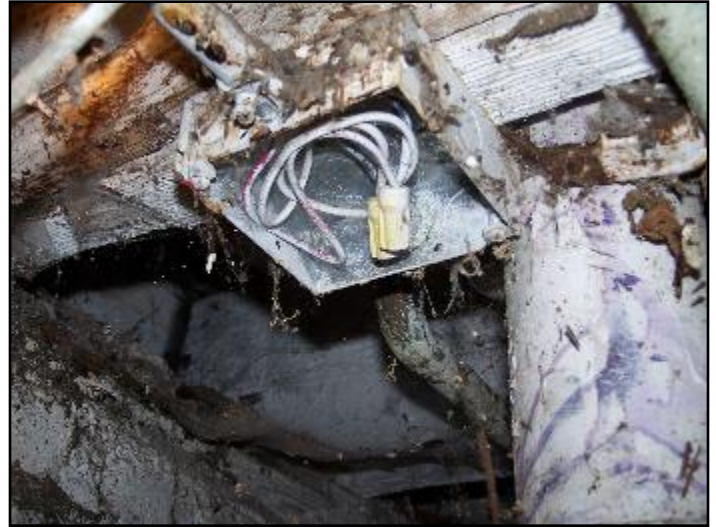
Open junction box

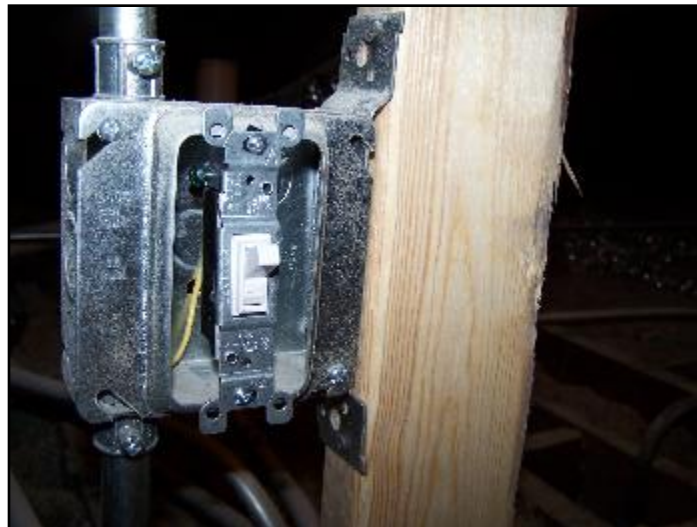
Missing switchplate cover

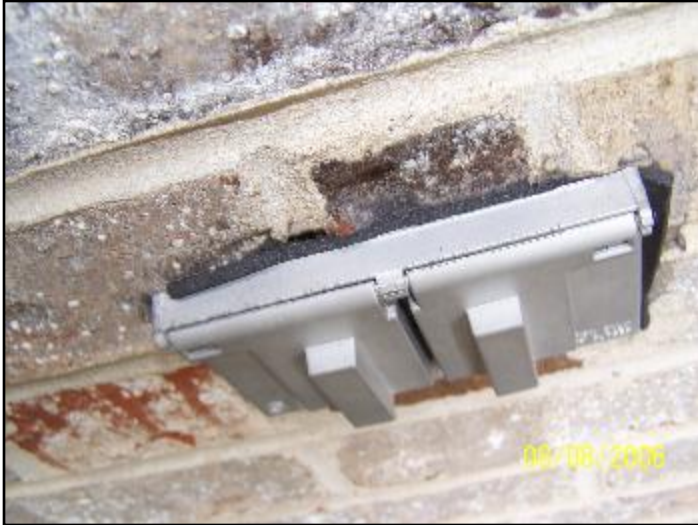
Note: Outlet issues noted throughout. ALL outlets should be examined and repaired or replaced by a licensed electrician prior to closing.

Exterior outlet not watertight, needs GFI

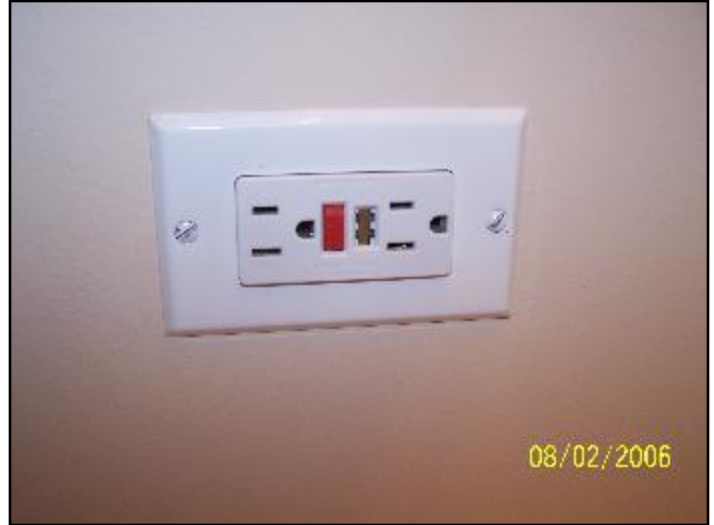
Damaged GFI

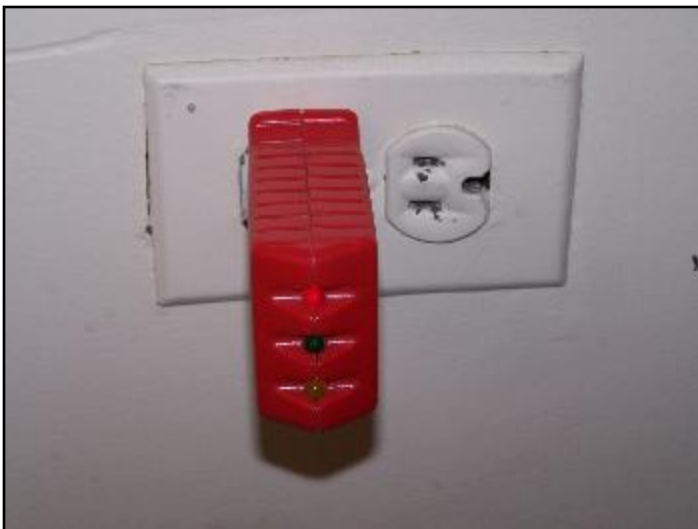
Bad ground

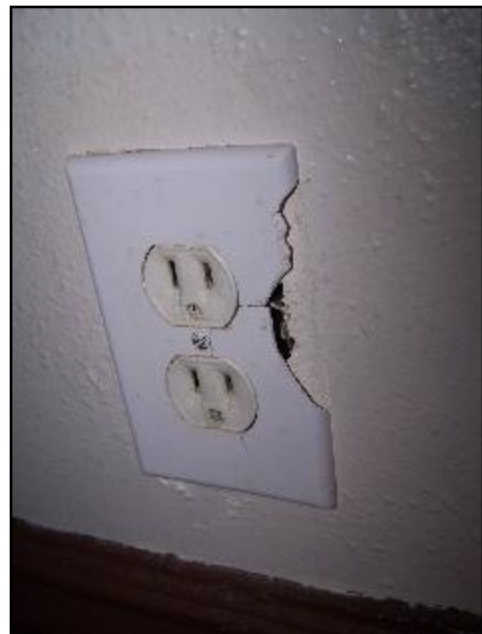
Cracked cover, paint clogged - replace
