INSPECTION REPORT

For the Property at:
1234 NICE STREET
YOUR TOWN, IL

Prepared for: JON DOE
Inspection Date: Friday, December 8, 2006
Prepared by: Thomas Jansson 450.0003340

Acuity Home Inspection Service
1340 W Farwell Ave
Chicago, IL 60626
312-217-5249
www.insightinspec.com
tj@insightinspec.com

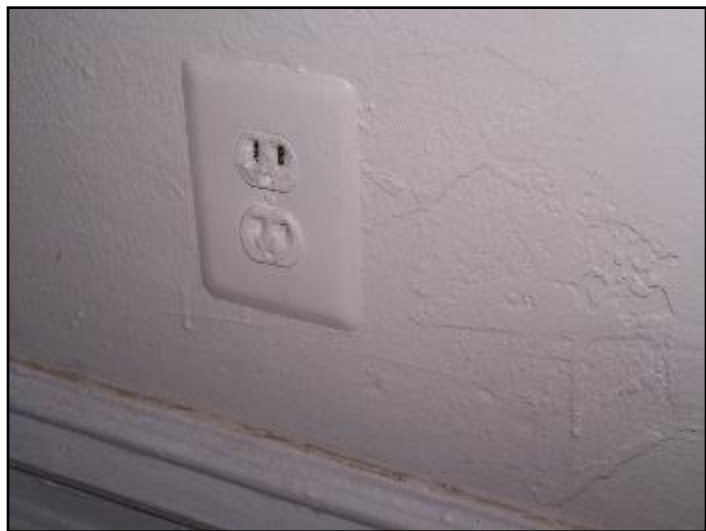
Paint damaged - replace

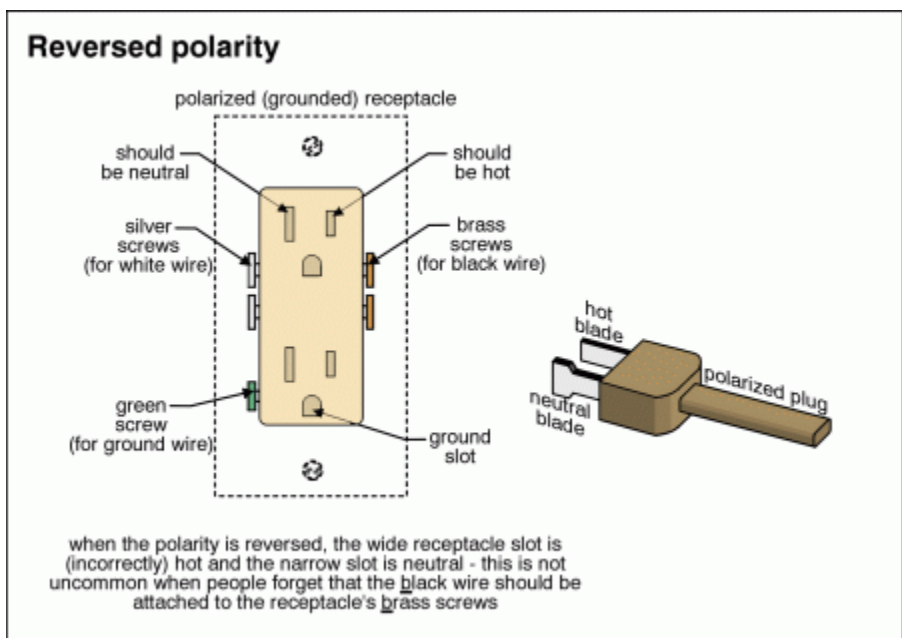
Condition: • [Reversed polarity](#)

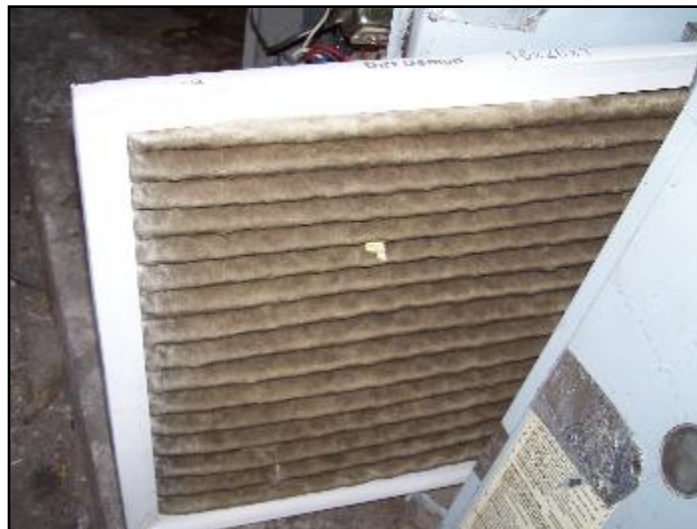
Condition: • [Dirty](#)

Replace dirty furnace filters

Note: Replace filter monthly to protect heating system and improve indoor air quality.

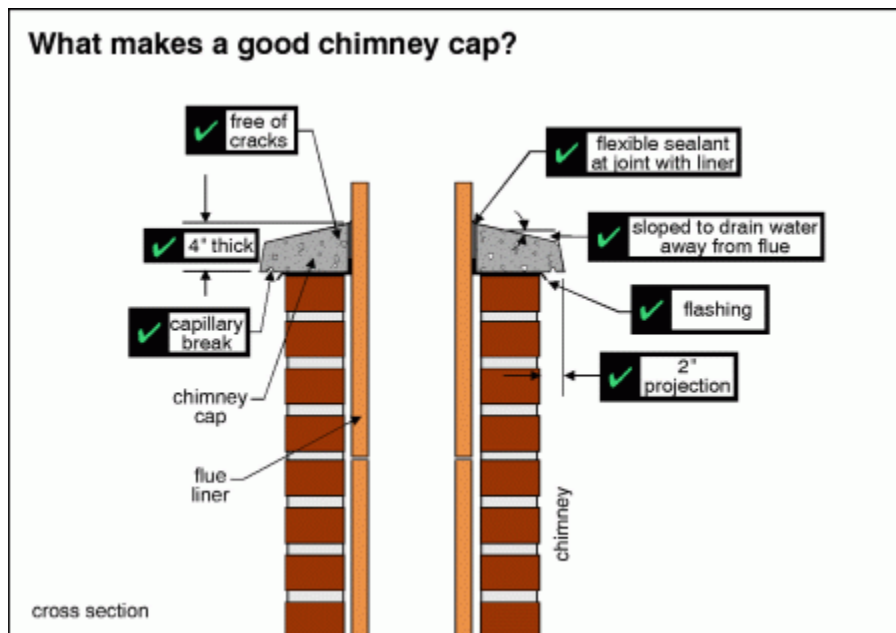
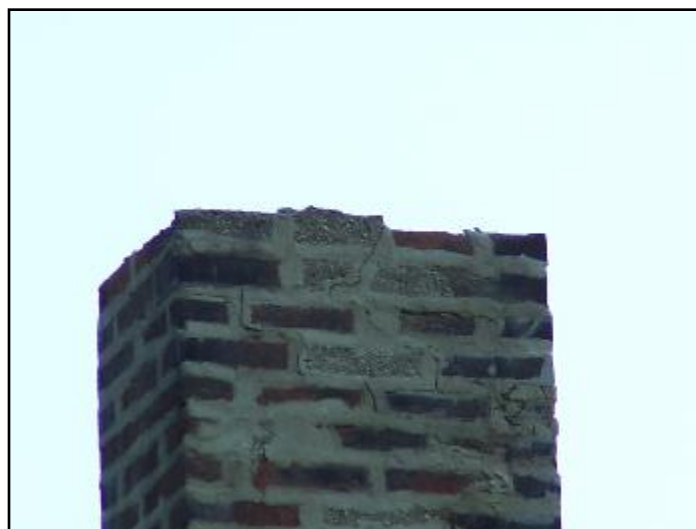
A chimney cap is necessary to prevent damage to the chimney from moisture intrusion and the freeze/thaw cycle.

Missing chimney cap; previous repairs

Note: Contact licensed masonry contractor for chimney cap replacement.

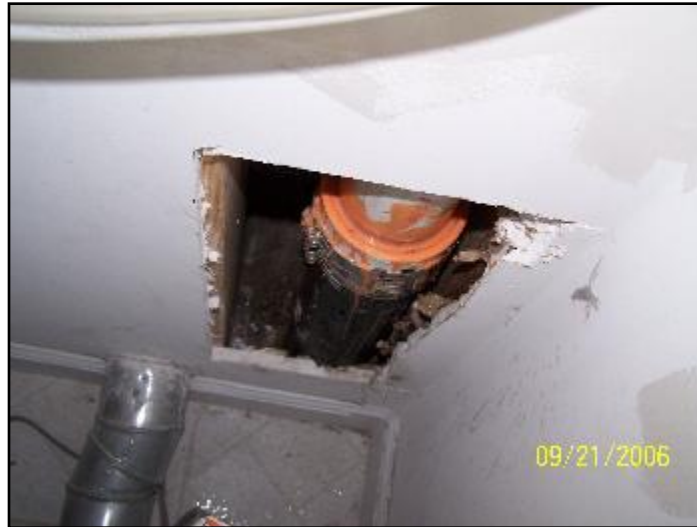
Note: Leaking waste stack found behind washing machine. Cannot determine location of the leak as the stack is enclosed by the walls. It will most likely be necessary to open up the walls in this section of the house in order to identify and repair the leak. This is a problem which requires immediate attention from a licensed plumber.

Leaking waste stack

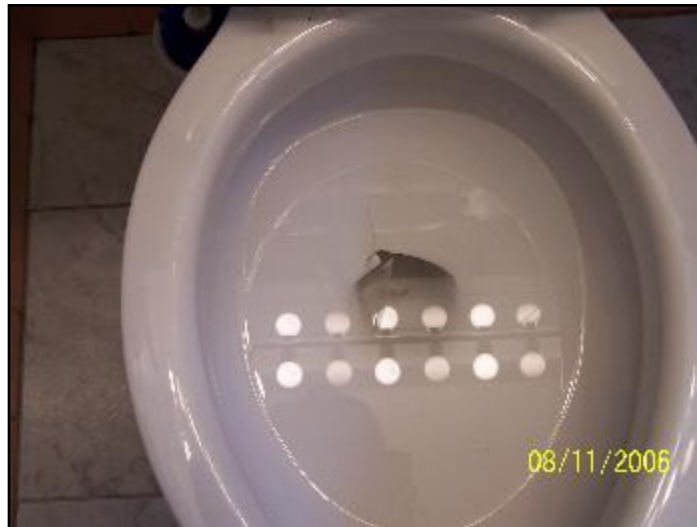
Note: Toilet is cracked and should be replaced by licensed plumber prior to closing.

Cracked toilet bowl

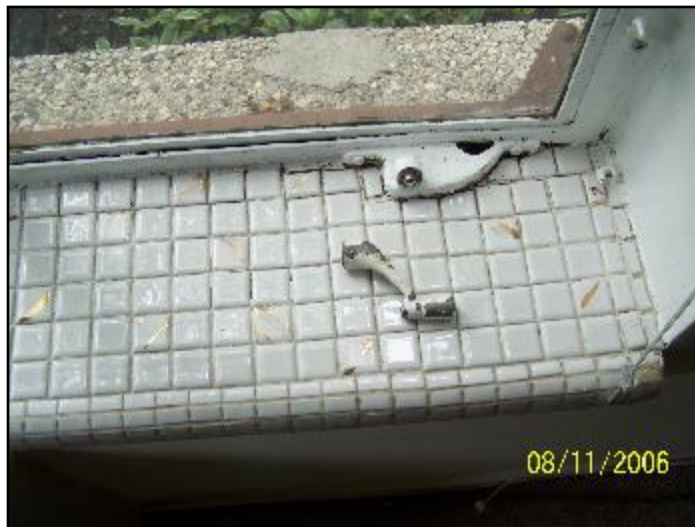
Condition: • [Inoperable](#)

Broken window hardware

Note: Replace damaged casement window hardware on back porch. A skilled homeowner may be capable of performing this repair, or a licensed handyman service can be used.

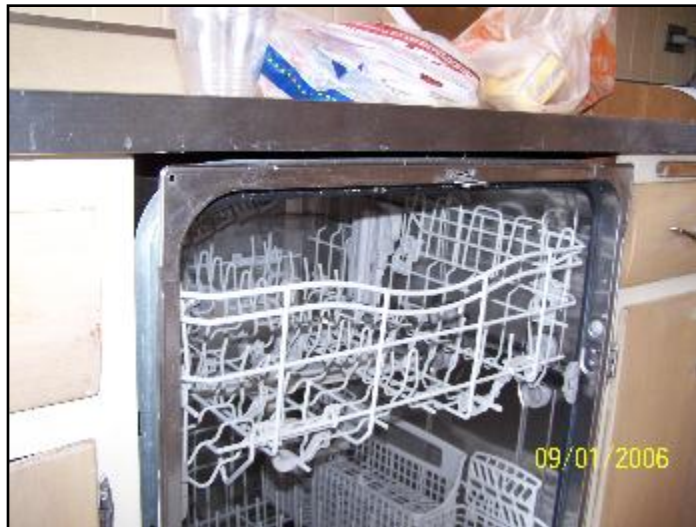
Condition: • Loose

Loose dishwasher

Note: Dishwasher should be secured to cabinets or countertop by qualified technician prior to occupancy.

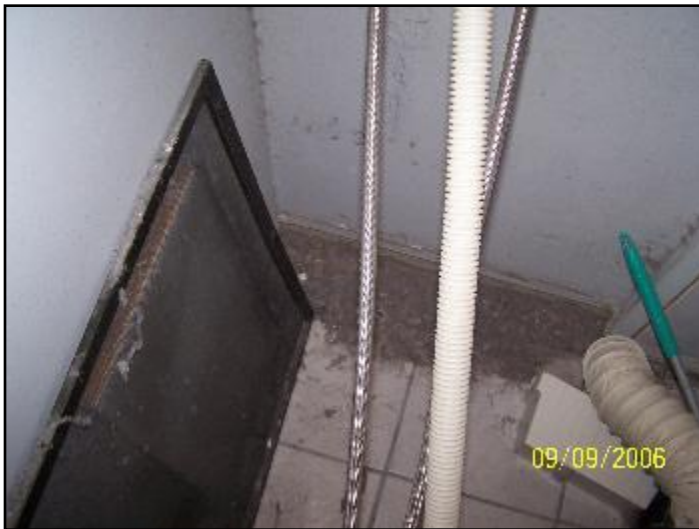
Note: Potential FIRE HAZARD.

Lint pile behind dryer. Fire Hazard.

Dryer should be vented to exterior with metal ducting. Plastic (or vinyl) ducting is flammable and should be replaced. Lint buildup is a significant FIRE HAZARD. Have Dryer Cleaned and Serviced by licensed appliance specialist prior to occupancy. Have Dryer vented to the outside using metal ductwork.

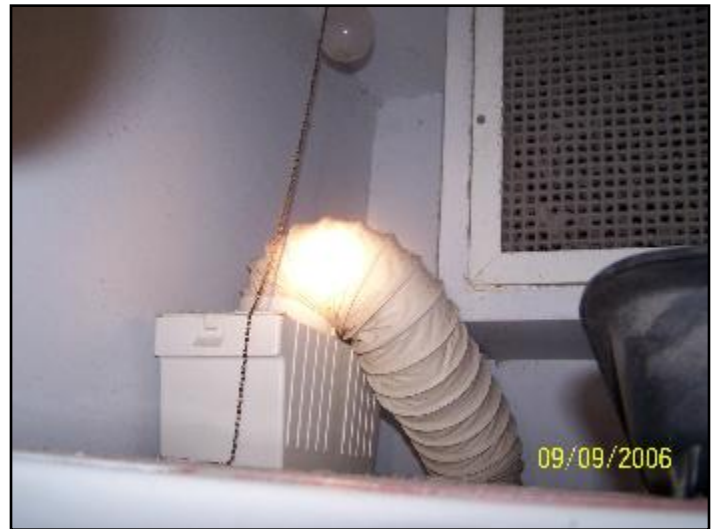
Lint trap, vinyl hose are fire hazards.
